TECHNICAL BULLETIN – TB-167

SERIES 90/100 PUSHBUTTON REMOVAL AND INCANDESCENT LAMP REMOVAL PROCEDURE.

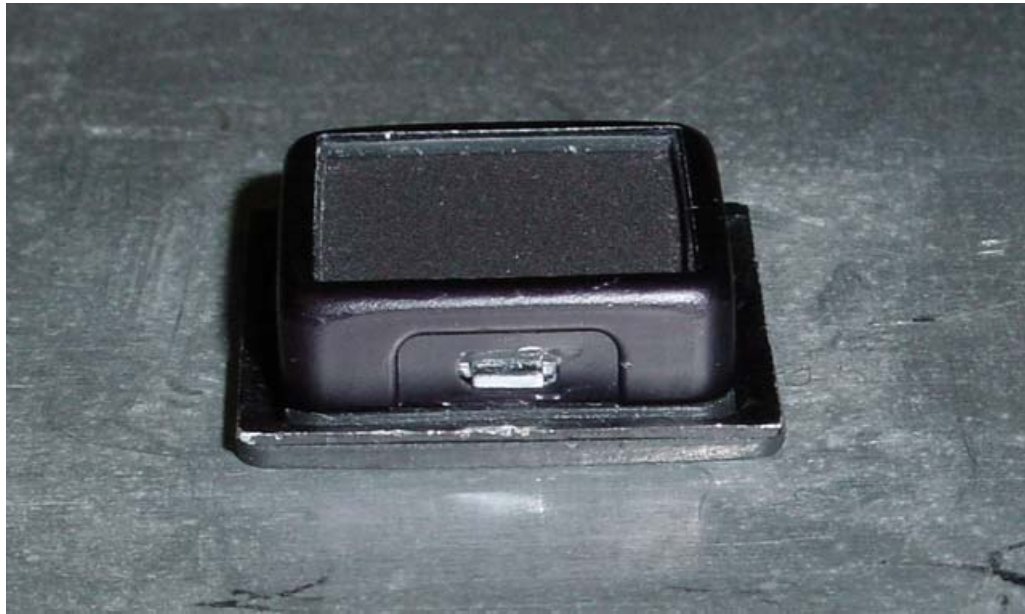
Figure 1. Unsealed and Splashproof Pushbutton.

FOR UNSEALED AND SPLASHPROOF PUSHBUTTONS (See Figure 1):

- 1.) For alternate action switches, assure that the switch is in the disengaged (off) position. Alternate action switches, when activated, are mechanically held depressed from the normal (at rest) height by approximately 0.080 inch (2.03 mm). To avoid internal switch damage, alternate action switches should be in the non-depressed state before attempting pushbutton removal.

- 2.) Using the Pushbutton Extraction Tool, PN: 15193, carefully position the tool's gripping tabs under the pushbutton's bezel retention tabs. This will assure that seals and bezels are not damaged in the removal process.

- 3.) Clamp/squeeze the tool gently, but firmly, and pull the pushbutton away from the switch assembly. This will require the application of up to five pounds of force.

- 4.) The pushbutton will release from its retention position and become free for service.
- 5.) To reinstall the pushbutton, align the index pin, at the rear of the pushbutton, with the index hole in the switch housing and push gently until the pushbutton is properly seated.

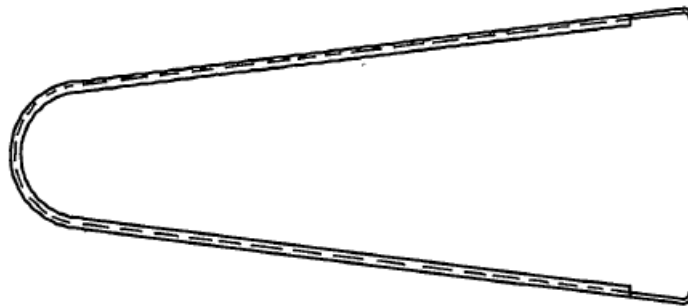
Figure 2. Pushbutton Extraction Tool.

The following instructions are intended to aid the user in the field to properly remove pushbuttons from the switch housing or matrix housing assembly and servicing incandescent bulbs. Standard pushbuttons are best removed using a pushbutton extraction tool. This tool is StacoSystems Part Number 15193. See Figure 2.

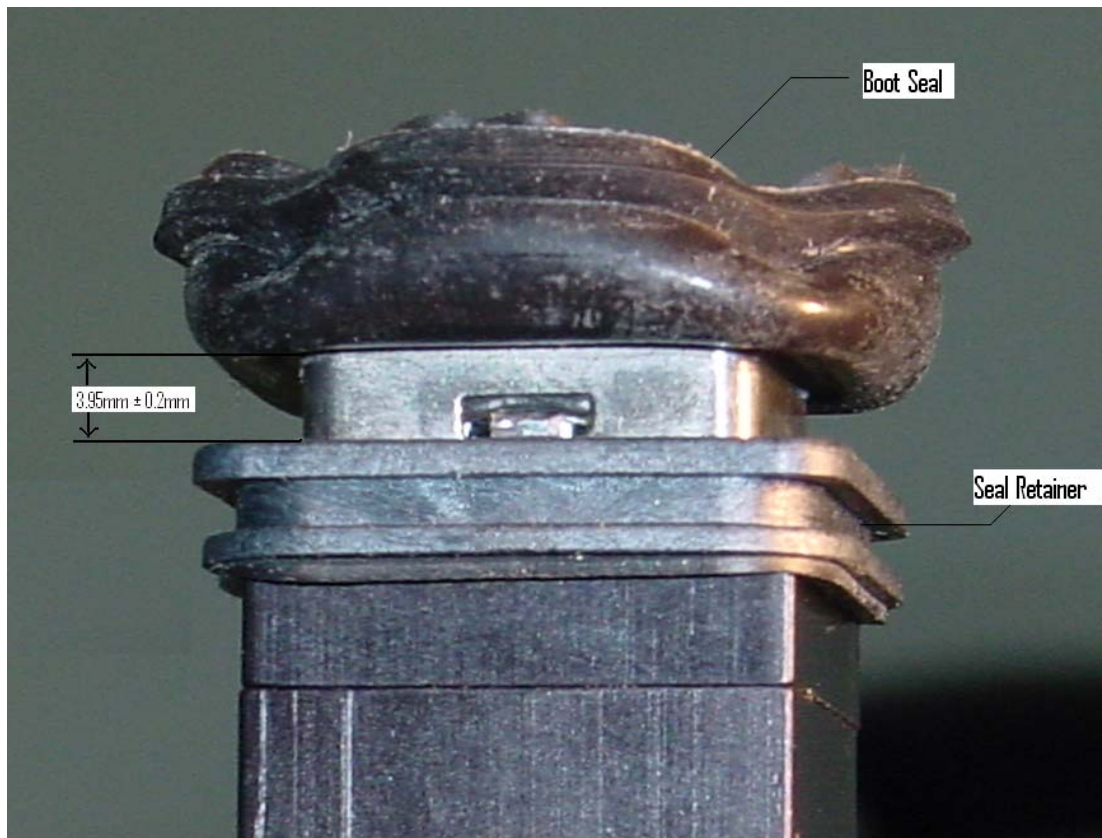
Figure 3 Watertight Seal turned inside out.

- 6.) Disengage the seal skirt from the retainer by turning the seal skirt upward and inside out. See Figure 3.
- 7.) As in Note 1 above, alternate action switches must be in the disengaged (off) position, as shown in Figure 3.
- 8.) Once the watertight seal is turned inside out, use your fingers to remove the pushbutton as shown in Figure 5. Use the extraction tool only if necessary and then use caution to avoid slips that could puncture the rubber seal.
- 9.) For reinstallation of pushbuttons with watertight seals, lubricate the inner ring of the rubber seal as necessary, with silicone grease, to facilitate re-engagement of the rubber inner ring into the retainer groove to maintain a good seal. Dow Corning EM-50L is recommended as the lubricant.

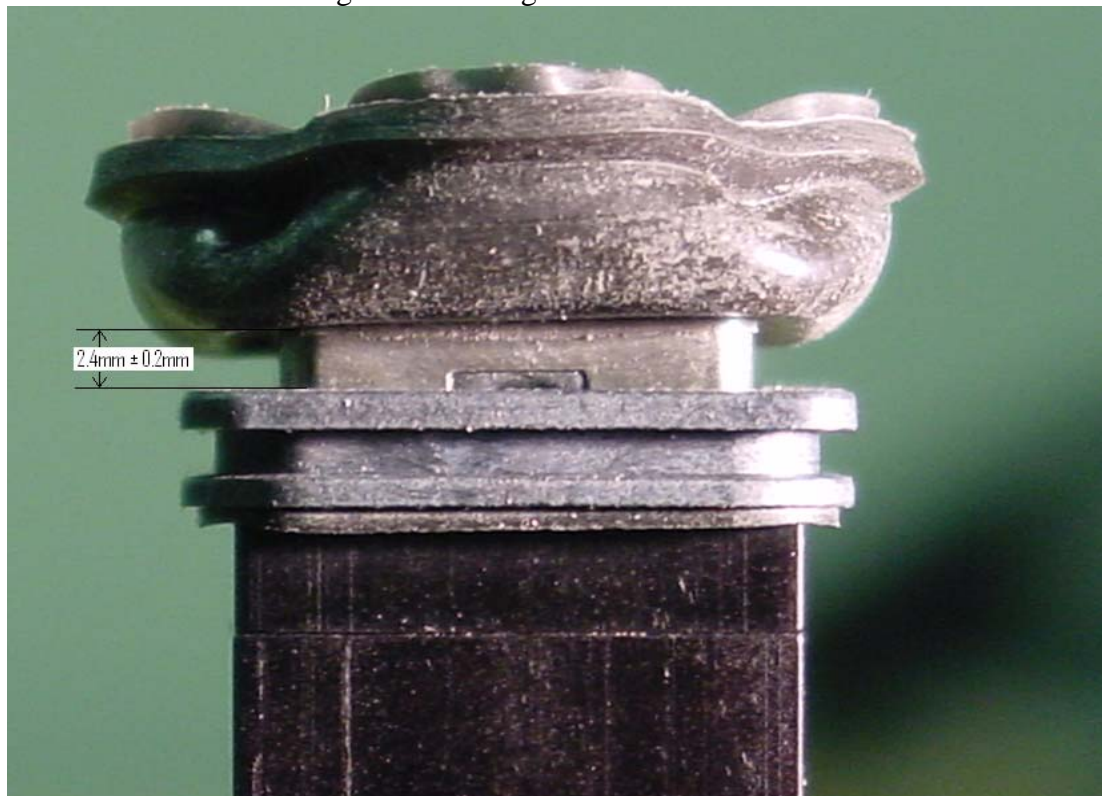
Figure 4 Pushbutton Depressed Alternate Position.

For alternate action switches, it is extremely important that the switch **not be** in the alternate or depressed position as shown in Figure 4. Otherwise, damage to the internal switch mechanism could occur.

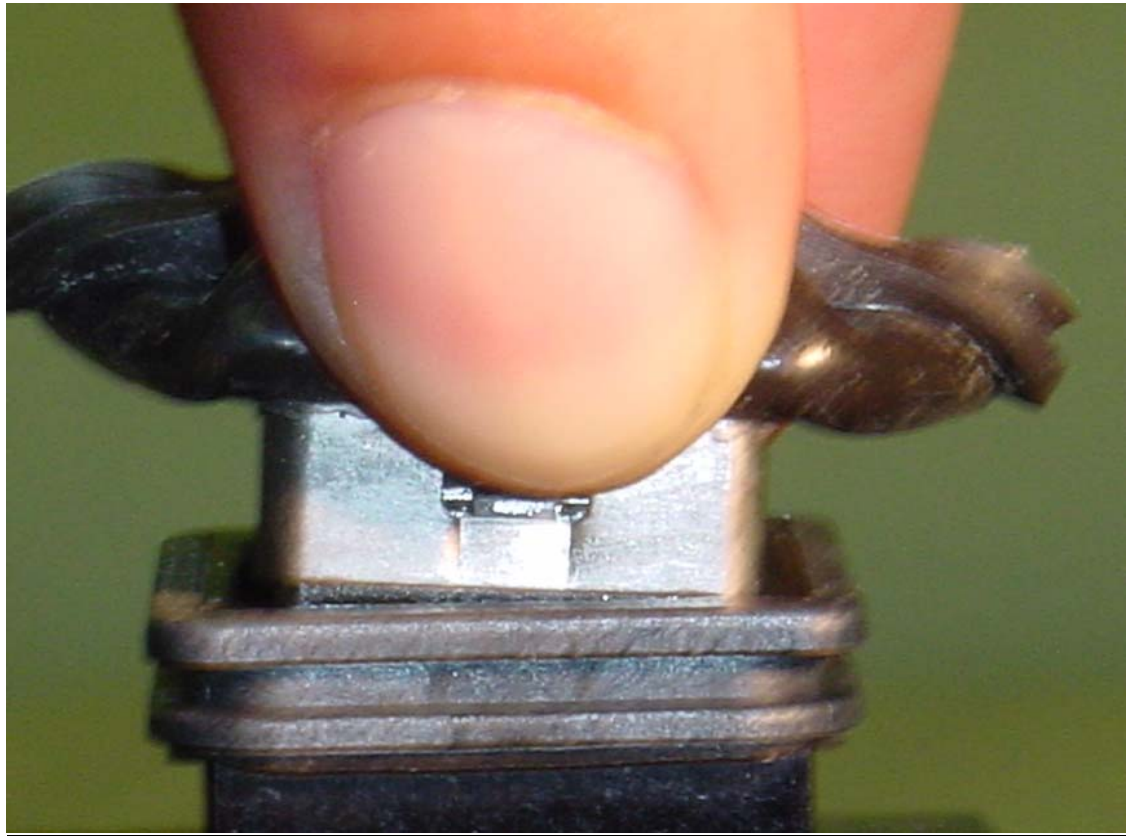
Figure 5 removal of Pushbutton.

FOR PUSHBUTTONS WITH A WATERTIGHT SEAL (see Figures 3, 4 and 5):

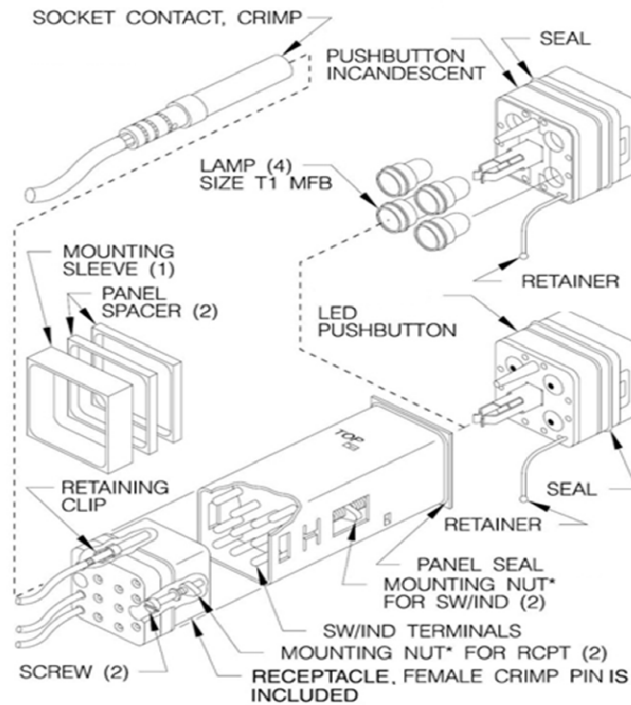
Figure 6 Typical exploded view with pushbutton removed

Once pushbutton assembly is removed from the switch housing, the user has access to the replaceable incandescent T1 size MFB (Midget Flange Bulbs) (See Figure 6)

The bulbs shall be removed by grasping the flange portion of the bulb with clean and degreased fingernails to initiate removal. No tools should be required for bulb removal. Use of tools can cause permanent damage to the assemblies circuit. During the removal process ensure that no contaminants or foreign objects enter the light chamber which could effect the original lighting performance of the device.

To install the bulbs, grasp the flange portion the bulb and insert into the open while avoiding contact with the glass on the bulb. Press bulb firmly into bulbs socket until seated. No tools should be required for this operation and could result in premature bulb life or permanent circuit damage.
